MONITORING OF HIGH RISE BUILDING USING VERY LONG FOCAL LENGTH OF CAMERA LENS AND THREE DIMENSIONS GOOGLE IMAGES

Dr.Entisar Kadhim Al-Geelawe¹, Dr.Layth Sadek Mohsin²

- 1) Assistant Prof., Civil Engineering Department, University of Baghdad, Baghdad, Iraq.
- 2) Lecturer Civil Engineering Department, Mustansiriyah University, Baghdad, Iraq.

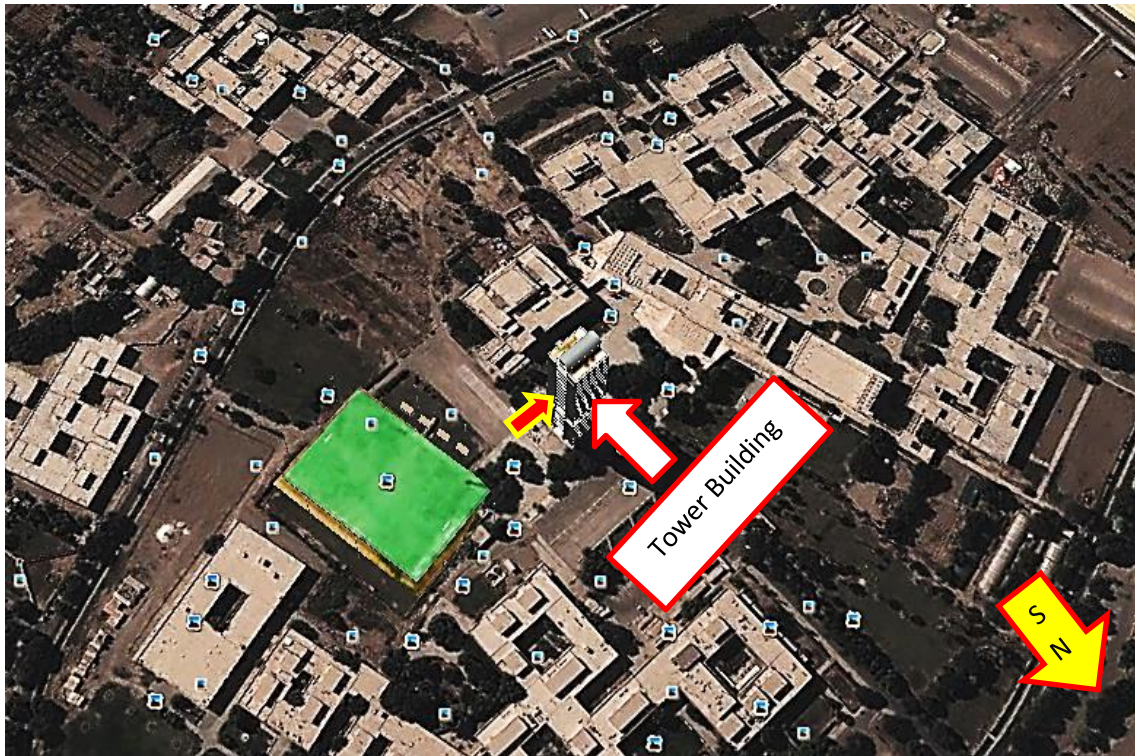
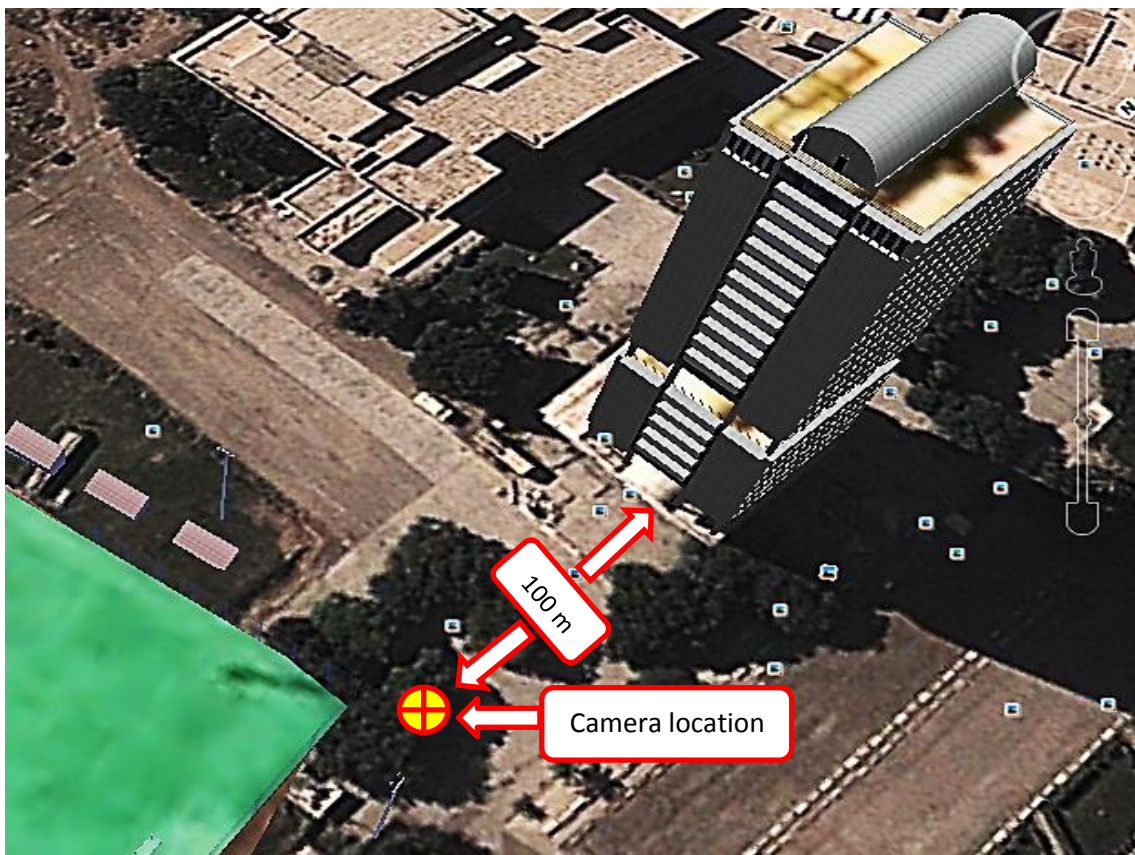
Fig. 6 (A & B) Google map of University of Baghdad.

Google Earth offer 3D images for some high rise and distinguishing constructions such for tower building of University of Baghdad which can be used to locate the damage clearly as shown in Fig. 6 (A & B).

The colored arrows show the direction of the images that covered the damages at the east side of the tower (red arrow).

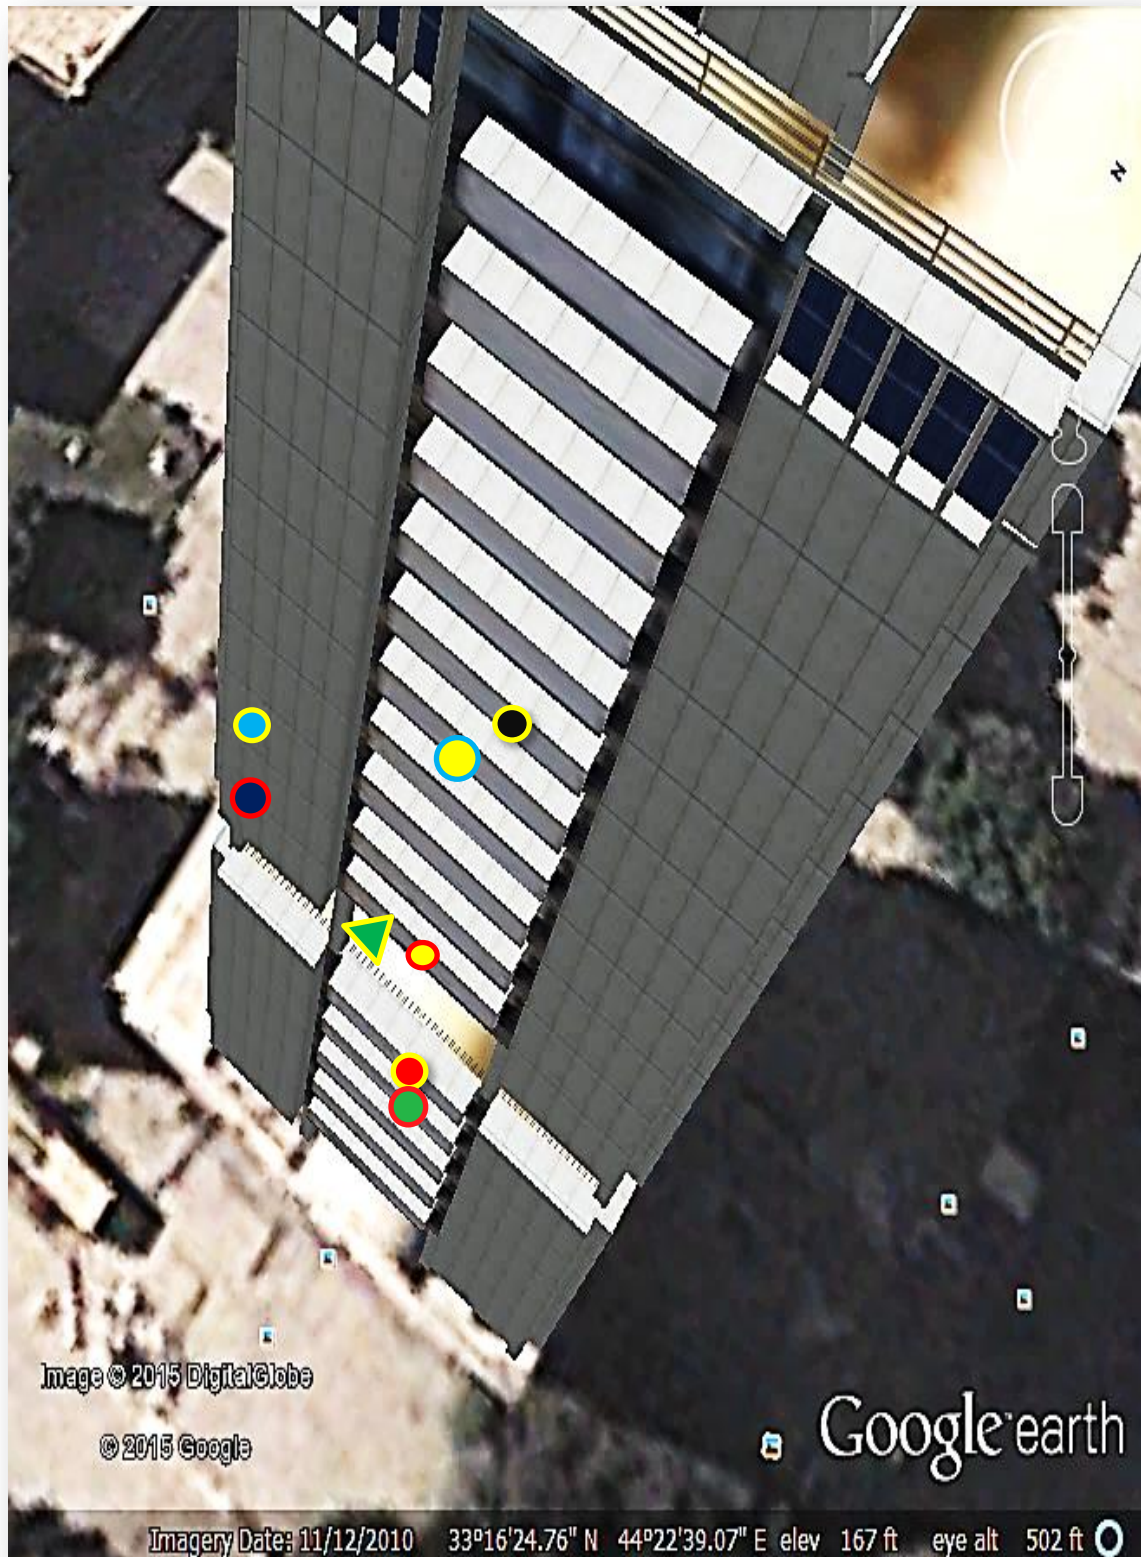
The locations of the damages are clearly presented at 3D view of Google map as shown in Fig. 7.

It is clear from this figure that upper parts of the tower are clearer than lower parts because the image was taken from the top on the contrary on that shown in figure 8 where the image was taken from the bottom and all damages were marked with a colored circle code for each damage.

Fig. 7 Google 3D view of the tower of University of Baghdad where the projectile damages are presented by colored circles and irregular opening in the roof presented by colored triangle (The image includes coordinates of the location which show latitude and longitude).

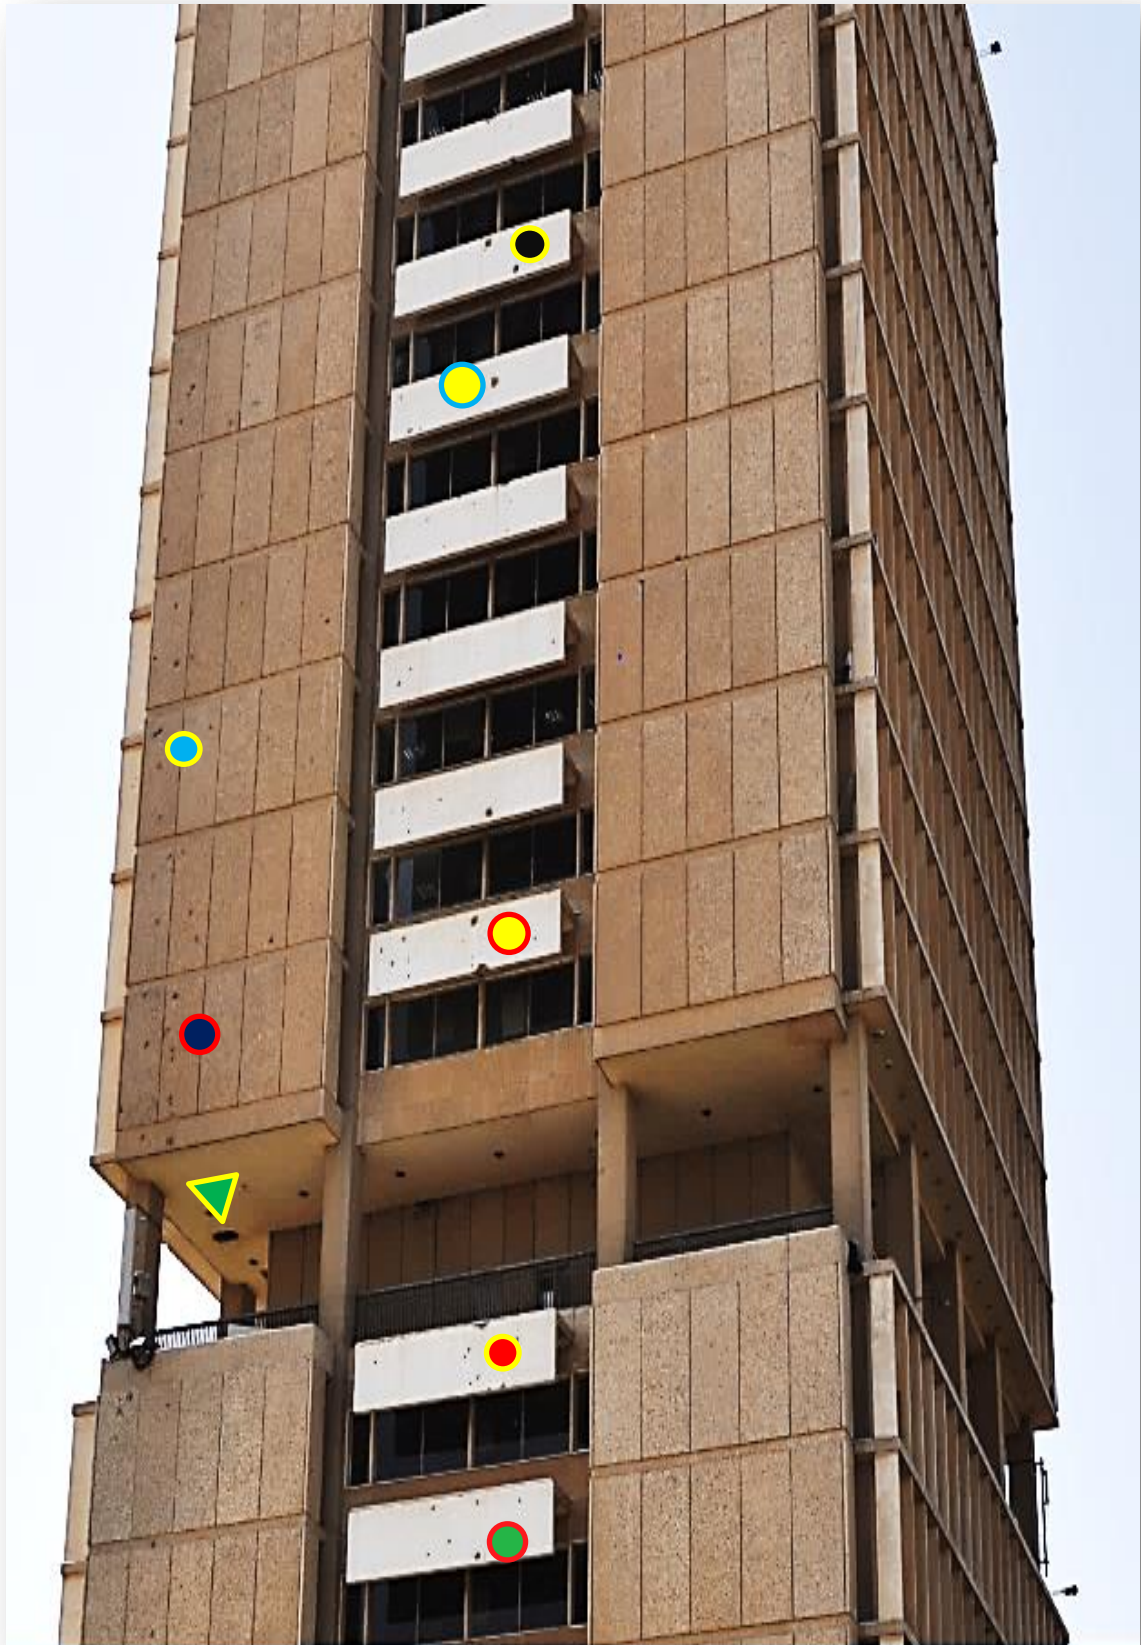
The lower parts of the building damages can be clearly presented on the normal building images as shown in Fig.8

Fig. 8 Image of the Tower of University of Baghdad which has projectile damages that presented by colored circles.

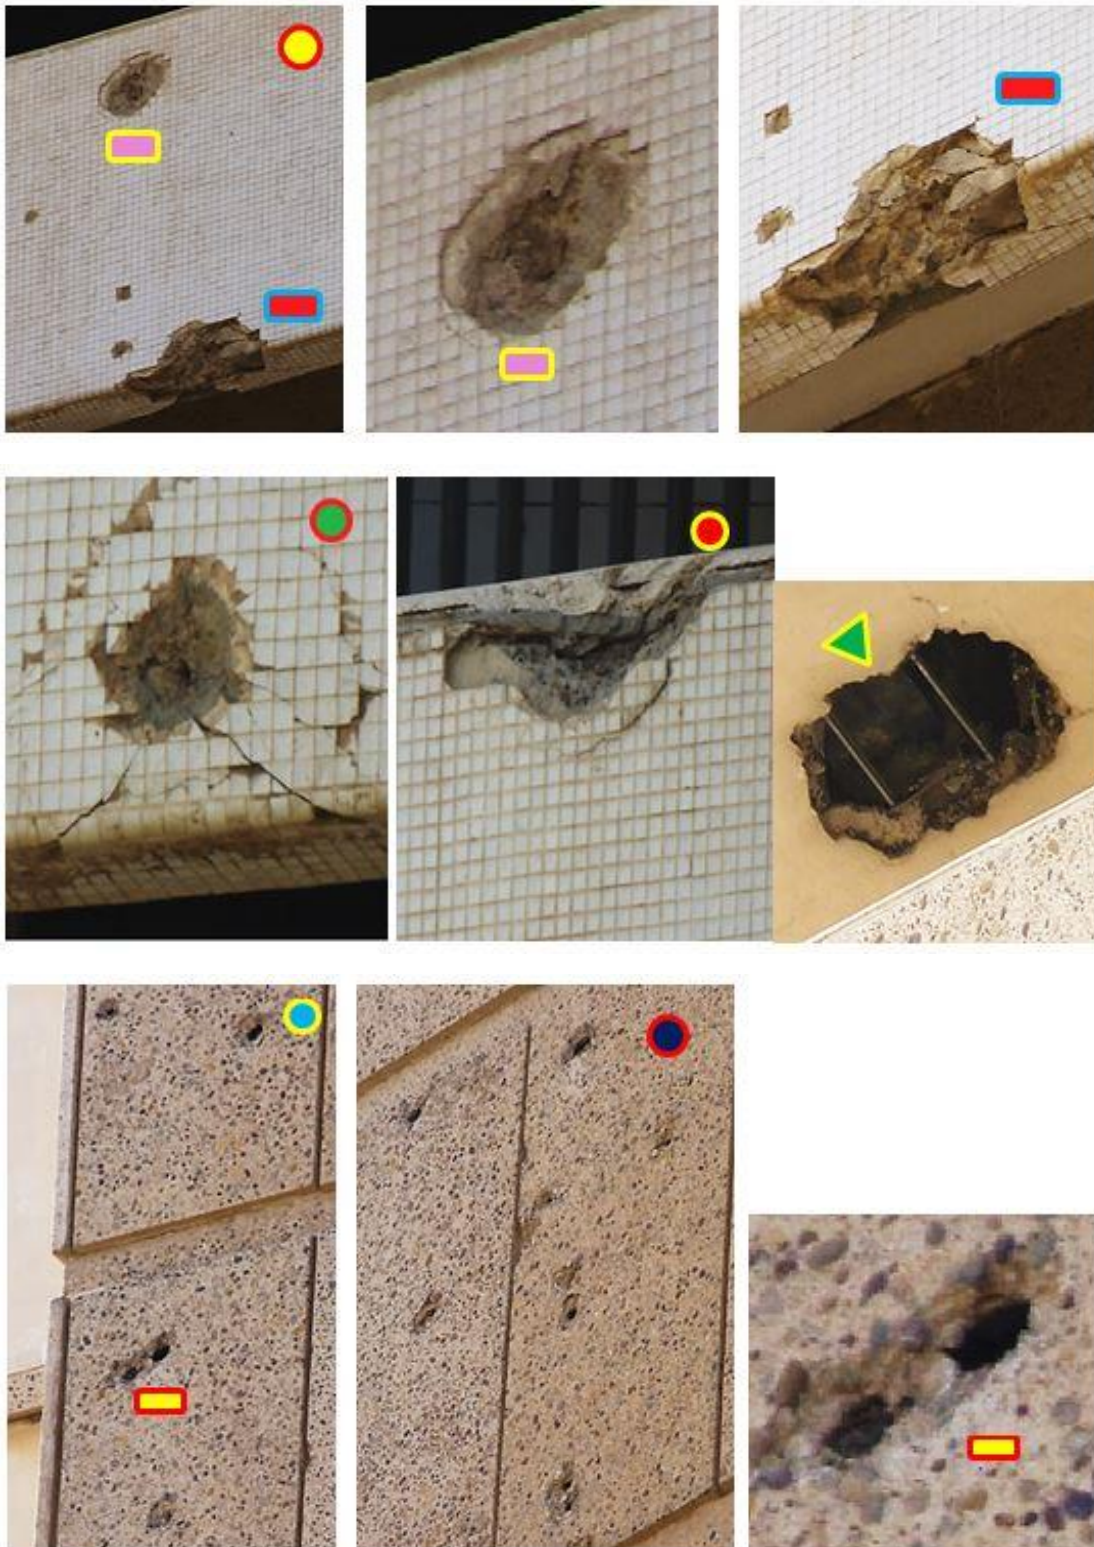
The damages caused by projectiles are shown in figure 9 for heights between 25-45 m while in Fig. 10 the damages for heights 55-60 m are shown according to their colored circle code.

Fig. 9 Damages caused by projectiles at an estimated height of 25-45m (Pentax K-x with MTO 1100mm 10.5).

Note: Damage in A is an irregular opening in the roof (is not caused by projectile, it may be caused by maintenance work).

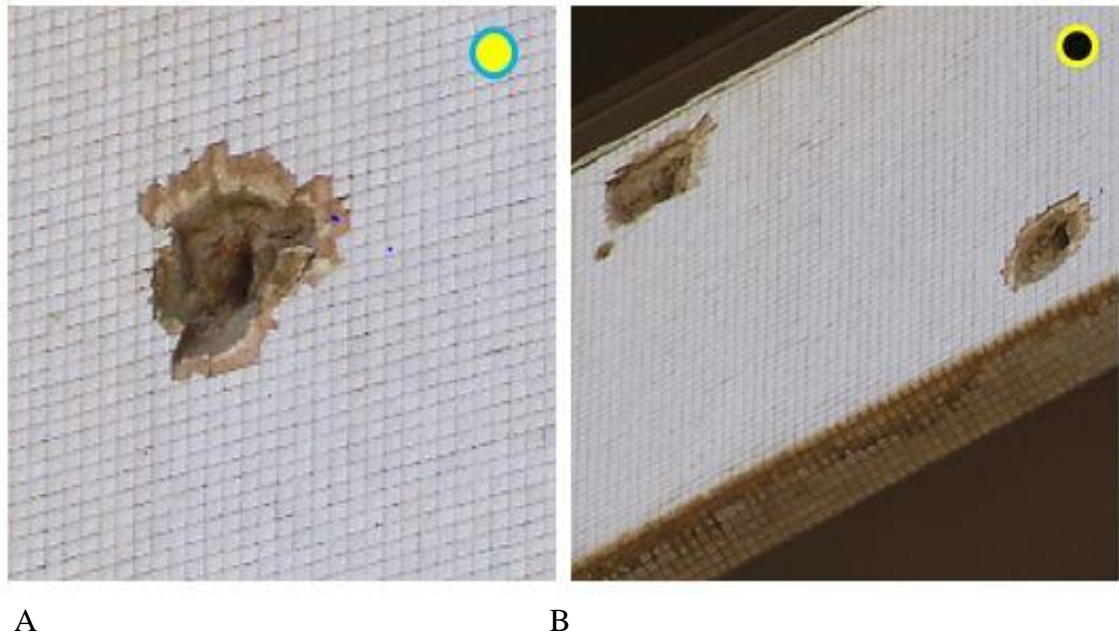
Fig. 10 Damages caused by projectiles at an estimated height of 55-60 m
(Image A by Pentax K-x with MTO 1100mm & image B by Pentax K-x with 55-300mm).
