THE APPLICATION OF ACCURATE DIGITAL CAMERAS WITH GPS AND USE THE GOOGLE IMAGES FOR MONITORING HIGHWAY BRIDGES

Dr.Entisar Kadhim Al-Geelawe¹, Dr.Layth Sadek Mohsin²

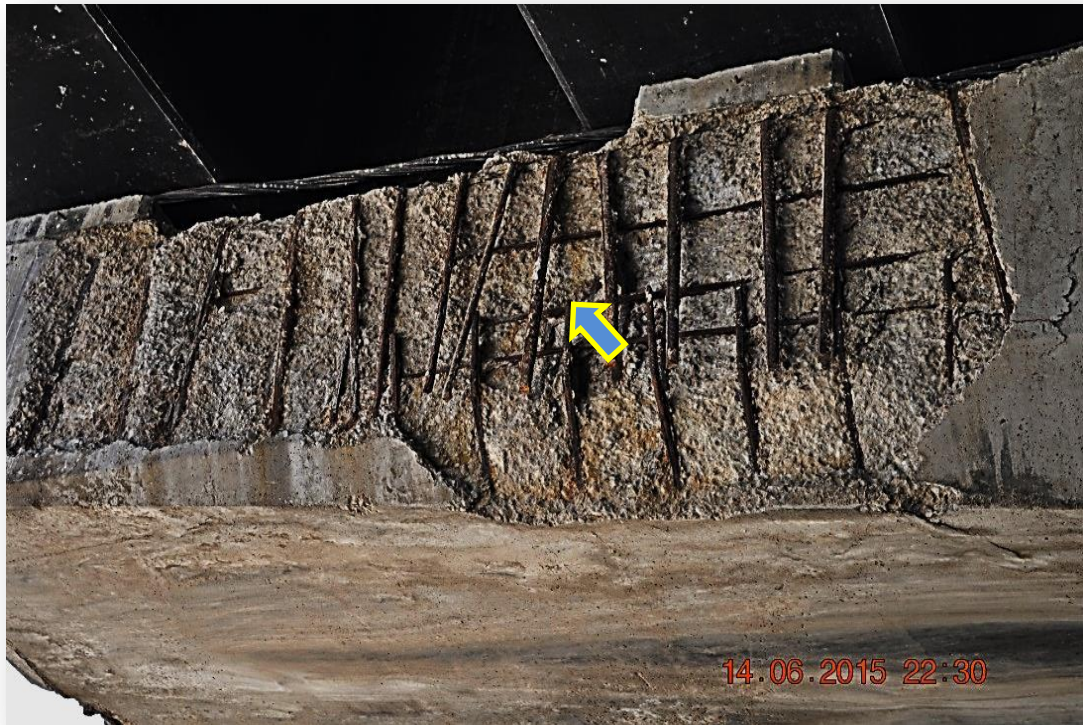
Fig. 5 Concrete delamination and exposure of Reinforcement in pier Capital due to heavy traffic loads & low strength of concrete cover.

It is clear that most damages occurred in pier and pier capital which are casted in place due to low concrete strength with respect to the high traffic loads, also some places suffer from insufficient cover thickness.

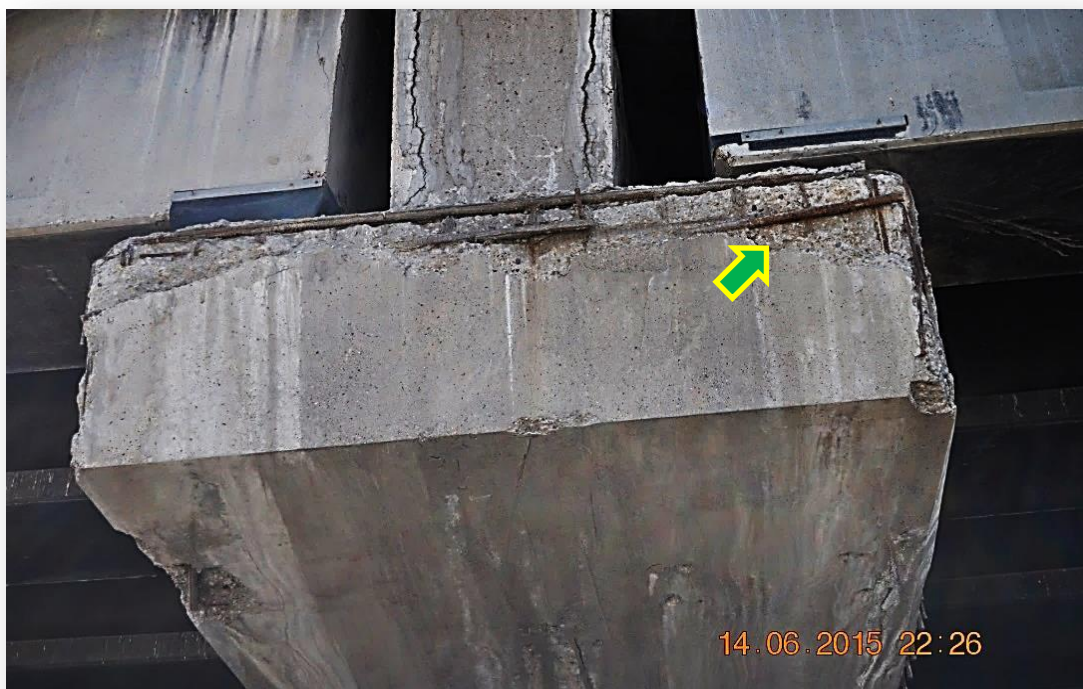
Fig. 6 Cracks, Delamination and Reinforcement exposure of Pier Capital due to heavy traffic & low strength of concrete cover.

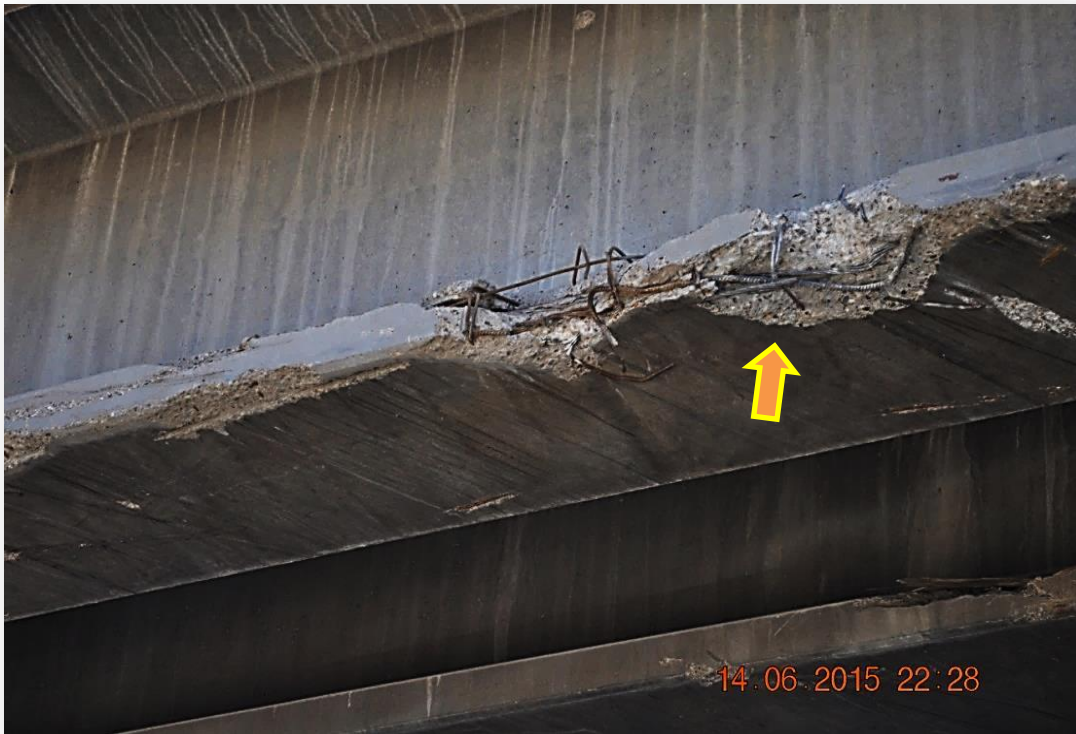
Fig. 7 Cut in wires of the girder flange due to crash with high-rise vehicles.

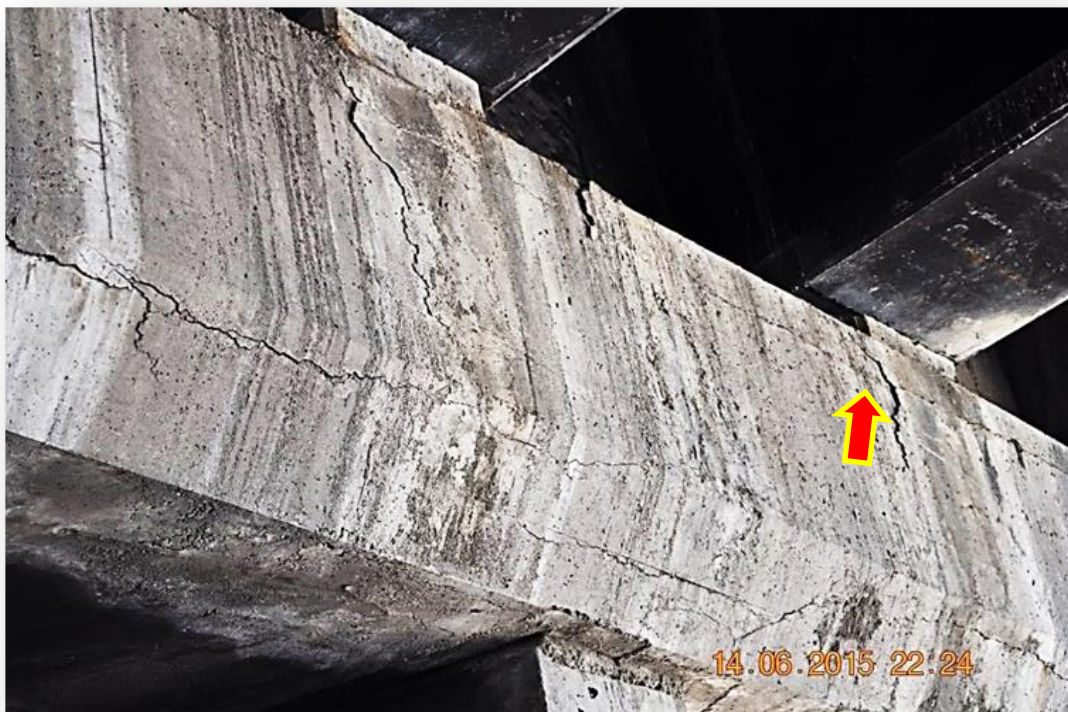
Fig. 8 Cracking in the pier capital due to heavy traffic loads & low strength concrete.

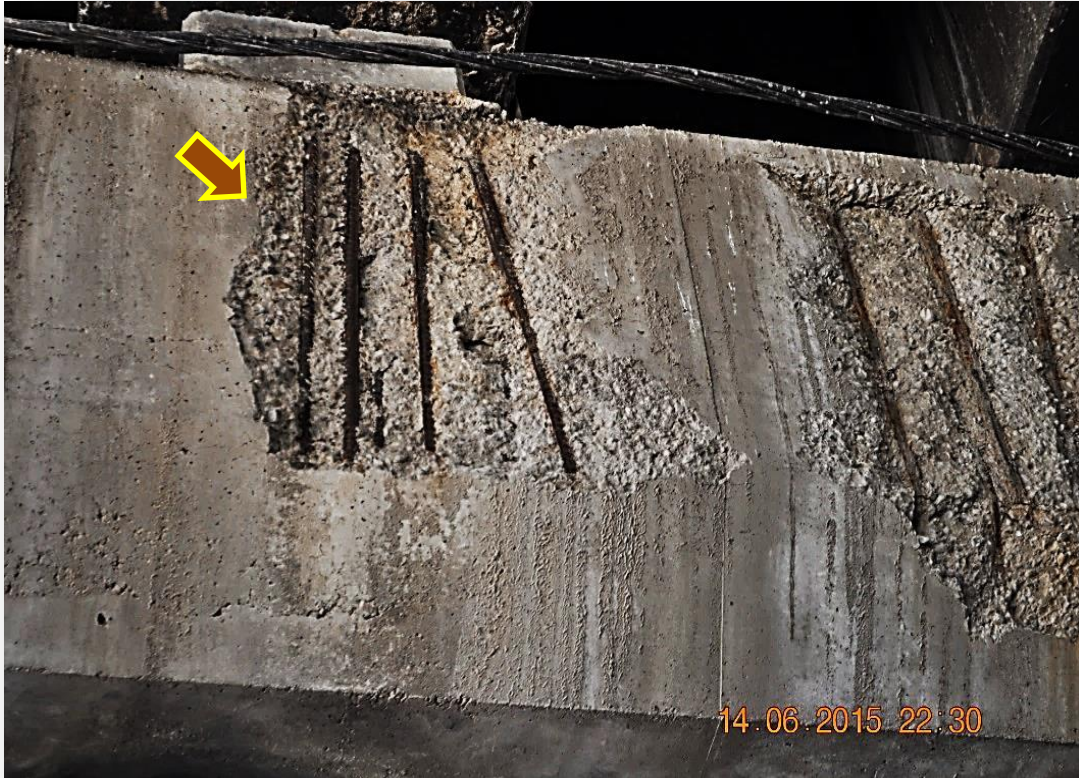
Fig. 9 Spalling and exposure of reinforcement in pier capital due to heavy traffic loads and low concrete strength.

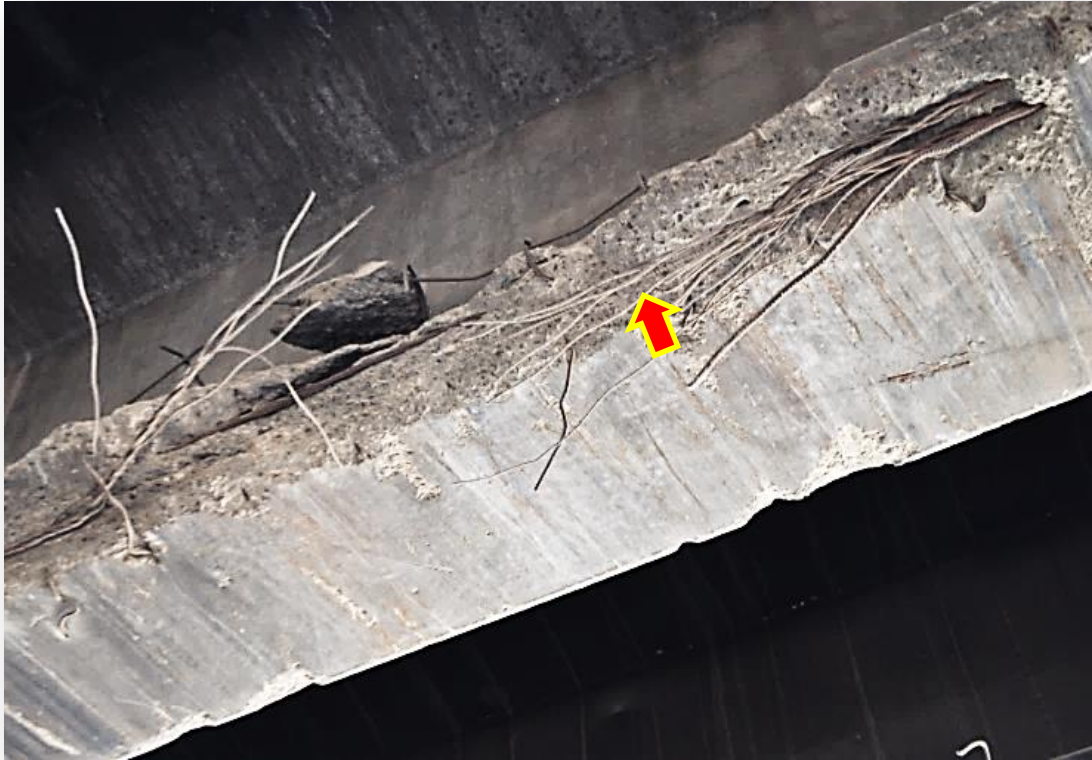
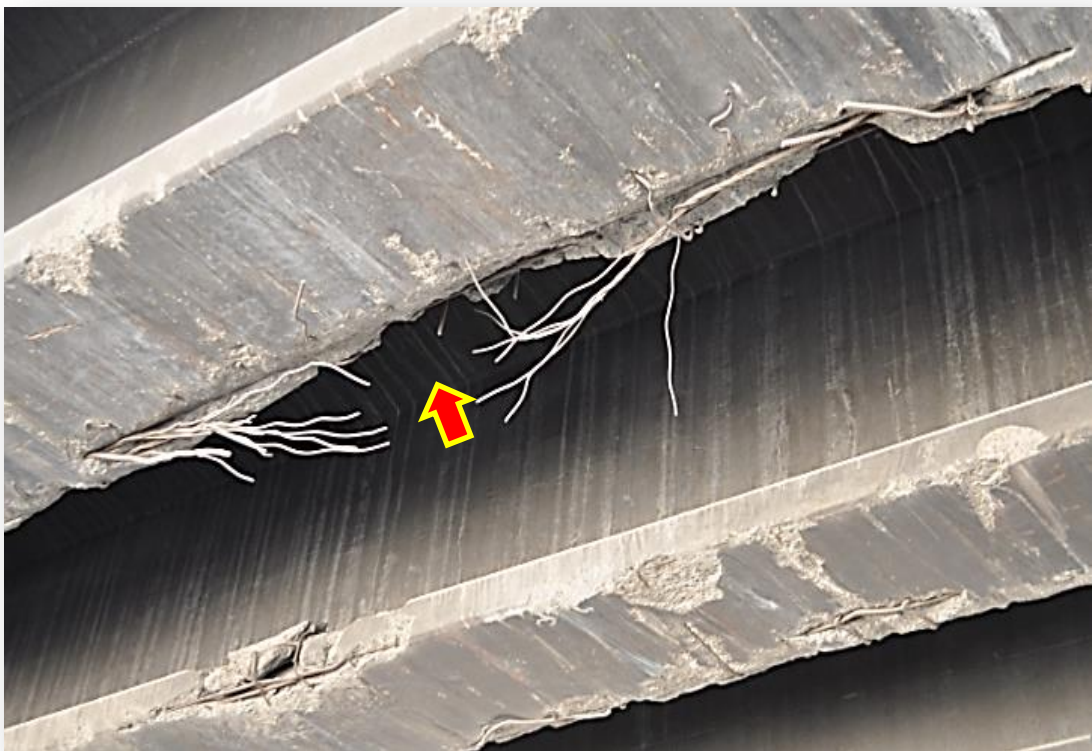
This location is characterized by the presence of a large number of girders suffered from crashed flanges that was mainly caused by accidents with crane vehicles resulted in cuts in post tension wires as shown in fig. 11, the other figures show the different damages that have been inspected there.

Fig. 11 Crashed girder flanges and cut post tension wires by accidents with crane vehicles.

Also some girders suffered from crashing by crane and high rise vehicles causing serious damages in girder flanges and cutting in post tension wires.

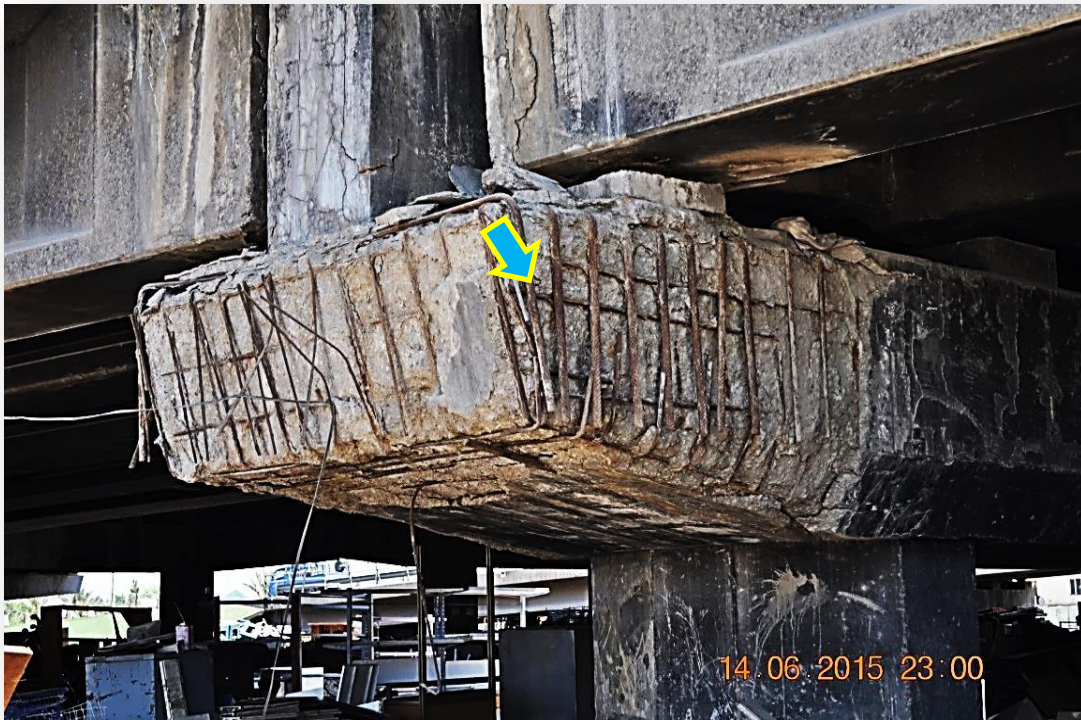
Fig. 12 The disappearance of the concrete cover and exposure of reinforcement of pier capital due to heavy loads & badly constructed.

- 1- Heavy traffic loads.
- 2- Insufficient concrete cover thickness.
- 3- Low strength concrete with respect to applied loads.

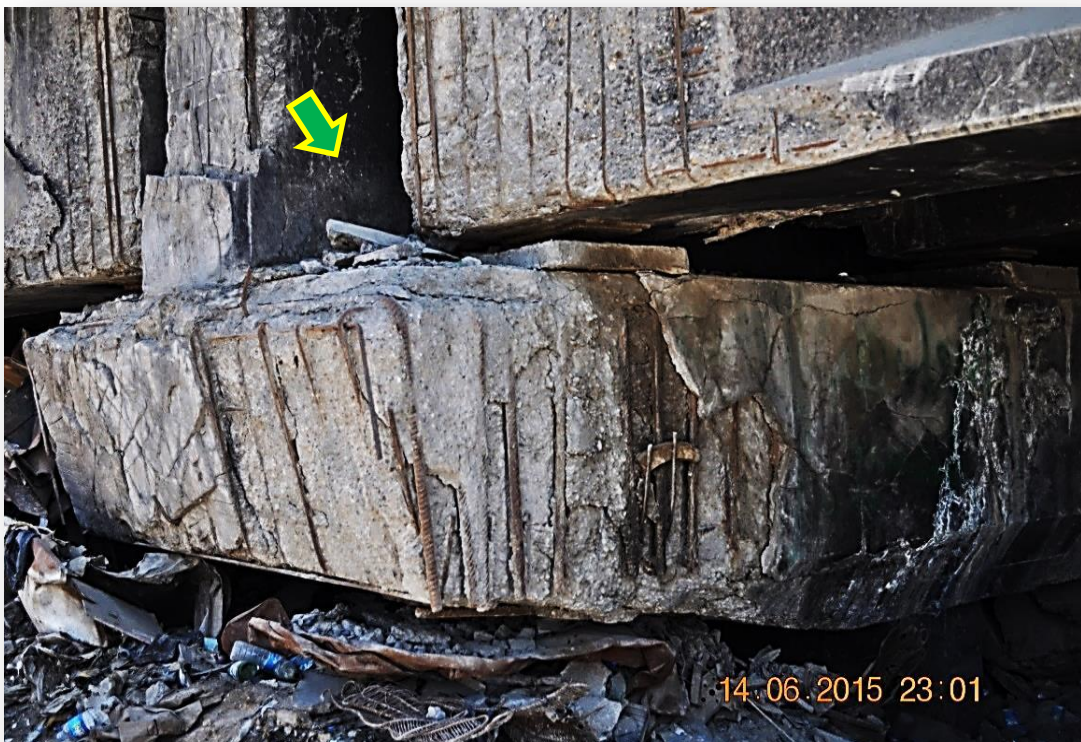
Fig. 13 The disappearance of the concrete cover and exposure of reinforcement of pier capital and girders.

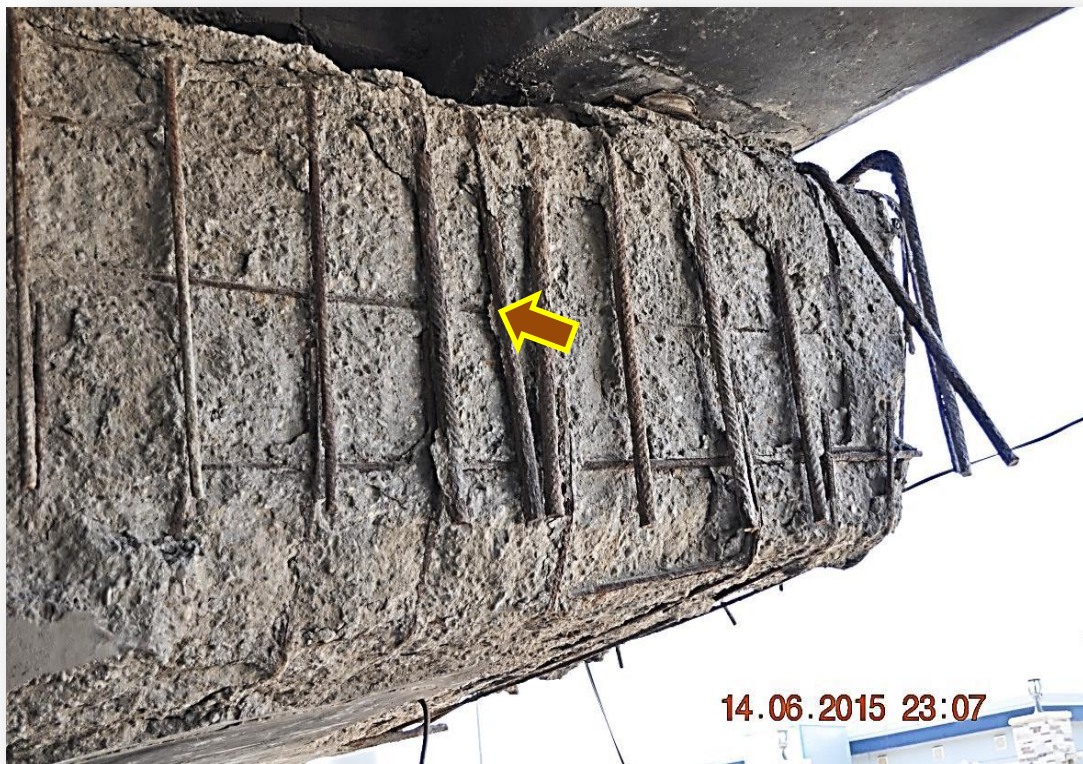
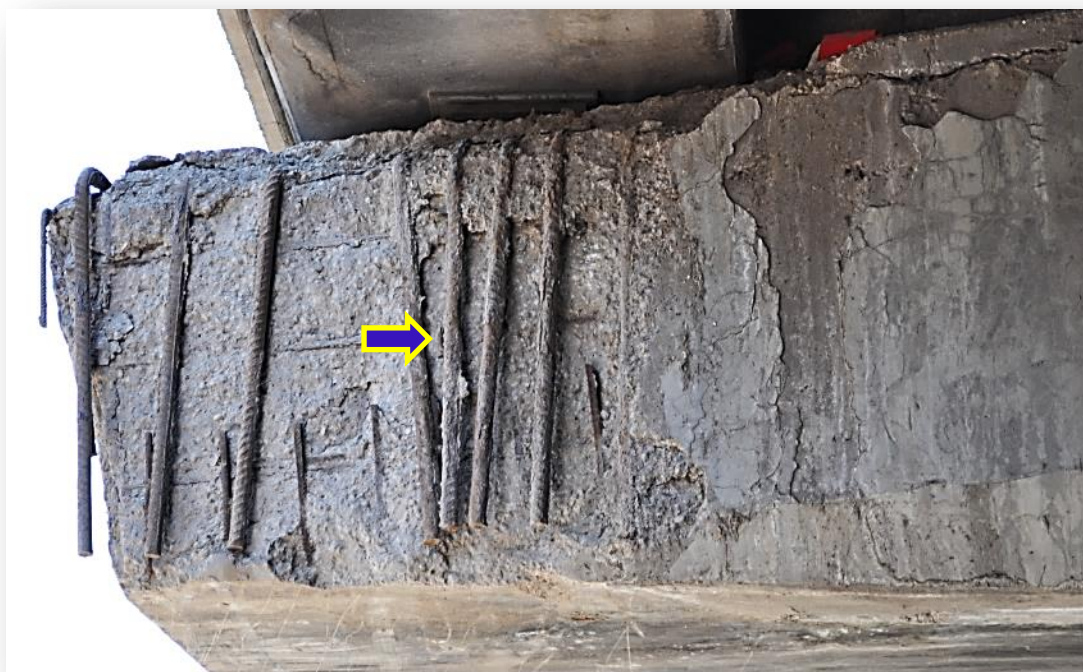
Fig. 14 The disappearance of the concrete cover and exposure of reinforcement of pier capital due to heavy loads & badly constructed.

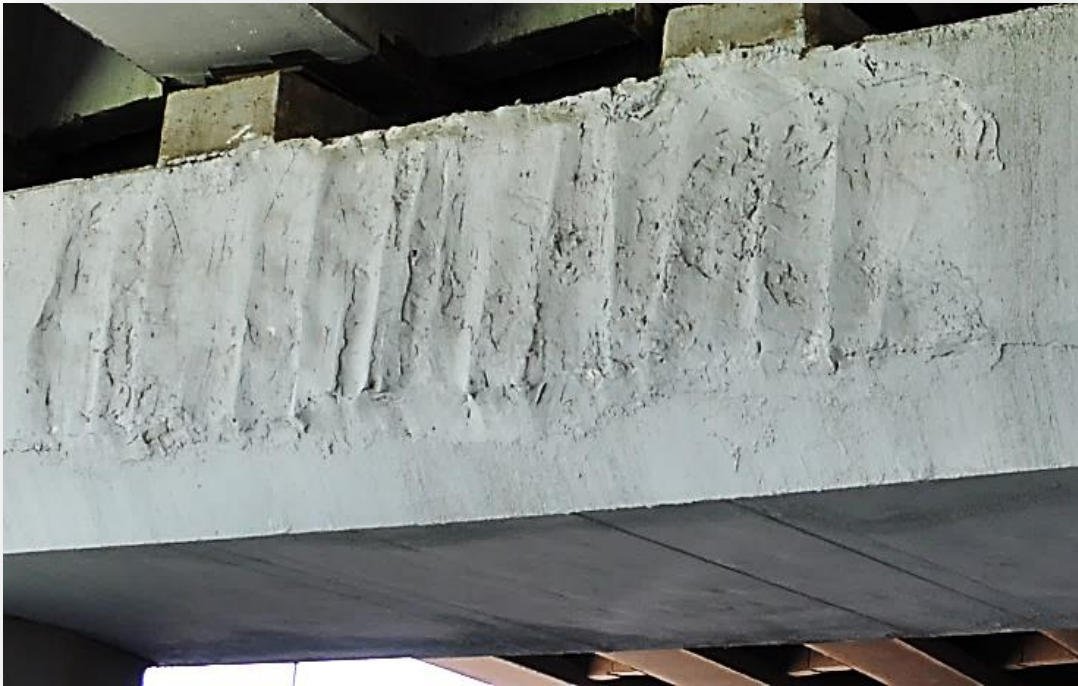
Fig. 15 Poorly repaired area in pier capital (just by plastering).

The damages that require attention have been identified, located and presented to Mayoralty of Baghdad to be utilized later. Some attempts have been applied to repair some of damages in pier capitals through using plastering method which may be the cheapest way but it is insufficient where most of those layers fell after a period so it has been suggested to use fiber reinforced cement after cleaning such places with sand blast.
