## Tube Damage Mechanism and Analysis in Feed Water Heaters

Asst. prof. Dr. Rafea Abbas Al-Baldawi  
College of Engineering  
Al-Mustansiryia University  
rafa\_a70@yahoo.com

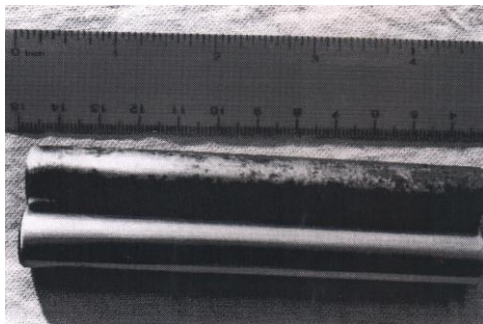
**(Fig. 1) Pitting of 15Mo3 tube in heat compared new tube**

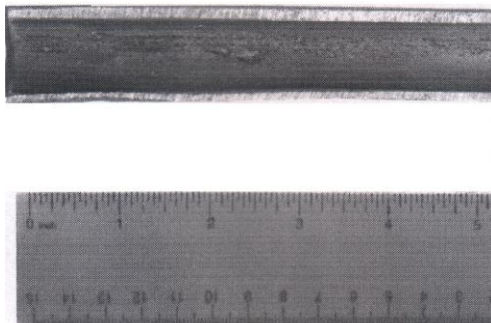
**(Fig.3) Inside tube erosion-corrosion For tube in desuperheating zone**

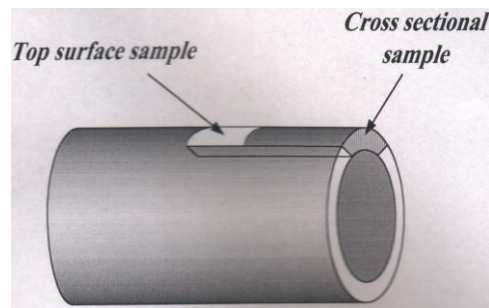
**(Fig. 4) Location of the samples carriedout for microscopic scanning.**

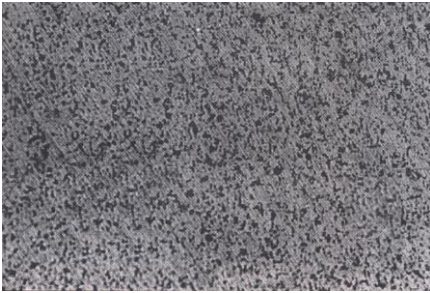
***(Fig. 5) Microstructure of low alloy steel used tube shows randomly distributed throughout the microstructure, dispersed carbide in ferrite***

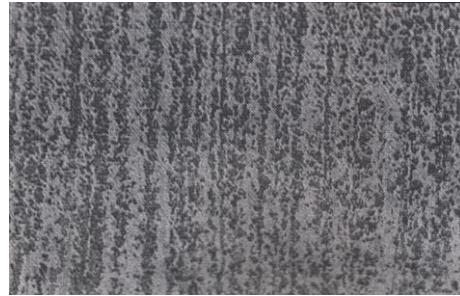
***(Fig.6) Microstructure of low alloy steel new tube shows homogeneously distributed of ferrite (light) and pearlite (dark)***

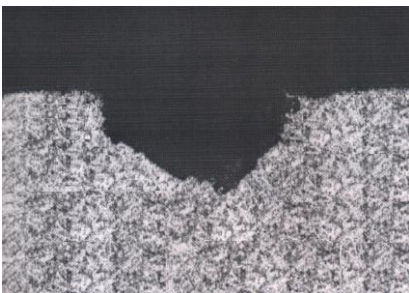
***(Fig.7) Microstructure of cross section used tube, shows the top edge hole and carbides***

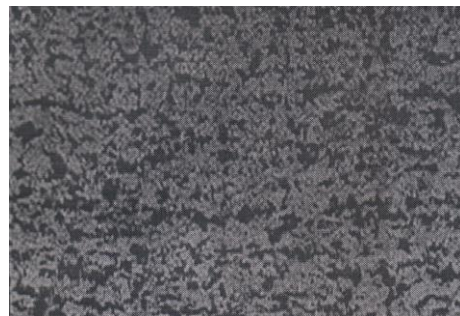
***(Fig. 8) Microstructure of cross section of new tube.***

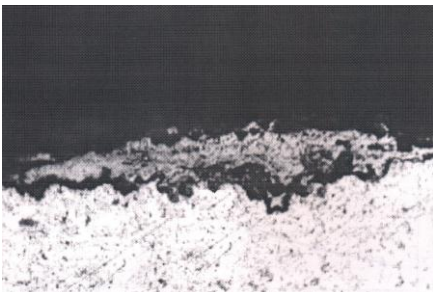
***(Fig. 9) Microstructure of cross section of used tube Shows corrosion which leads to cut part from the top Surface, producing a hole with time.***
