## **Load-Deflection for Epoxy Repaired High Strength Reinforced Concrete Beams**

### **Abstract**

*This paper presents an experimental investigation to predict the load-deformation behavior of High Strength reinforced concrete beams that failed in flexure and were repaired by epoxy injection.*

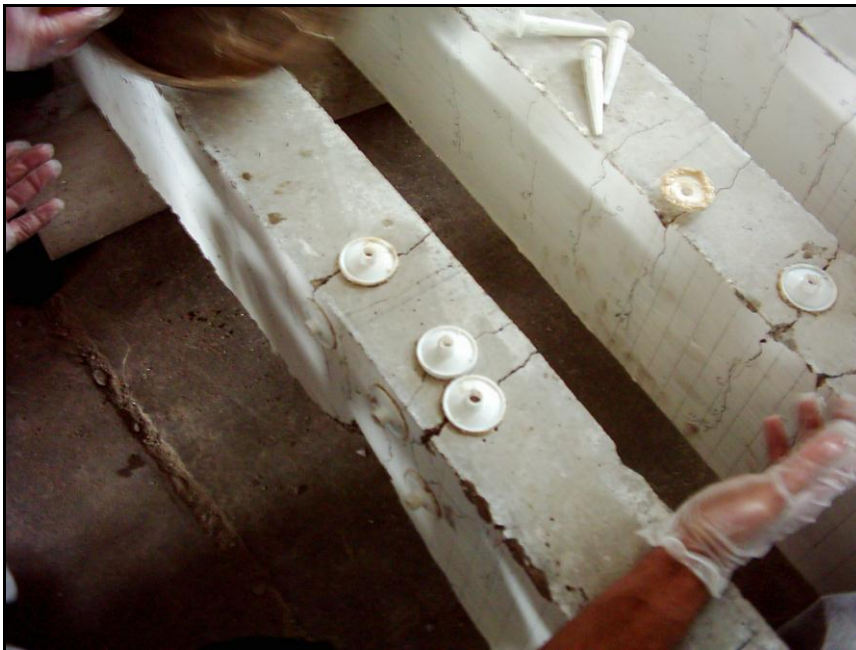
### Plate (3) Epoxy injection for beams

5. A mechanical injection gun is fed with the mixed epoxy and the injection process started. The injection process began by pumping epoxy into the lowest port until the epoxy began to flow from the port above it. The first port was then plugged with a cap, and the process was repeated until the crack has been completely filled and all ports have been capped. Low pressure was used in injecting epoxy into the cracks. A curing period of about 24 hours was provided to the injected epoxy <sup>[2]</sup>.

similar manner. The repaired beams were left at ambient temperature for one day and then tested to failure as before. **Plates (2), (3) and (4)** show that test procedure of beams and epoxy injection respectively.

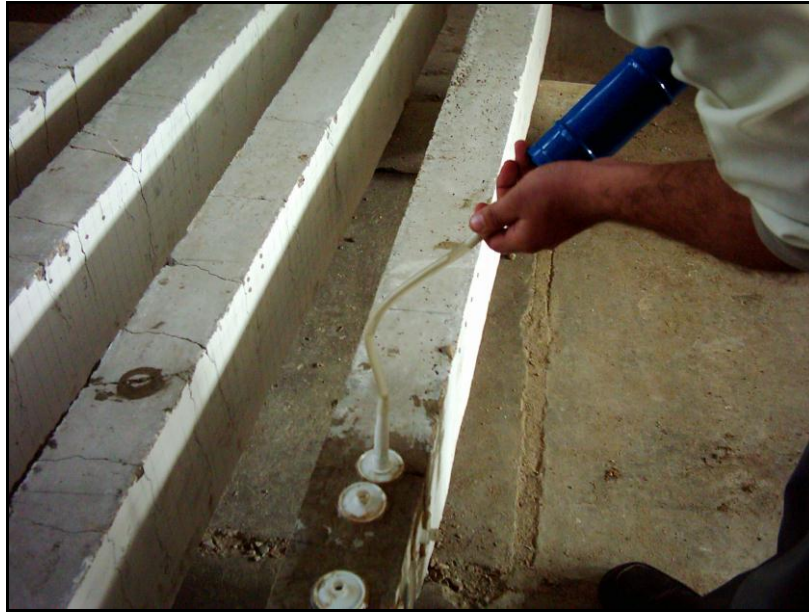
Plate (4) Epoxy injection for beams
