# Stability Assessment of Cut Slopes Along Kasara Ghat on National Highway 3

**Keywords:** Cut Slopes, Factor of Safety (FoS), Rock Mass Characterization, Slope Destabilization.

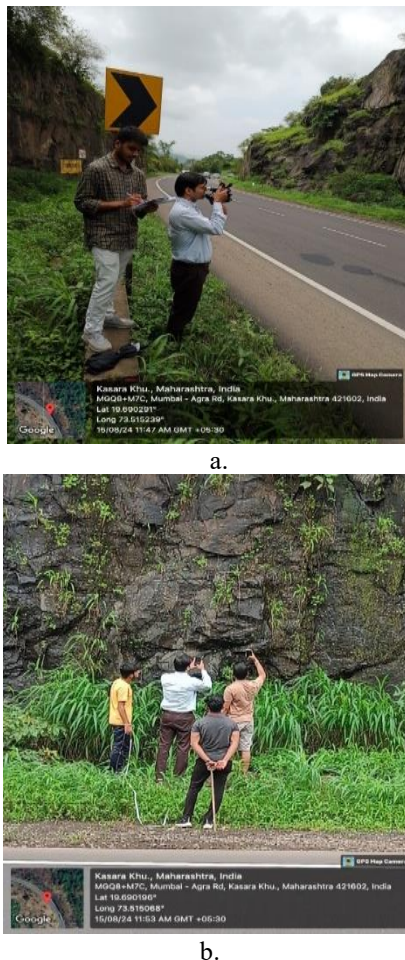
**Figure 3.** Field measurements using a nautical sextant.

Field measurements were conducted using instruments including a nautical sextant to assess the inclinations and potential movements of the cut slopes as shown in Fig. 3. Readings revealed subtle but noteworthy changes in slope angles at specific locations, indicating potential areas of concern. Field photographs documenting the condition of the investigated slopes along NH-3 are presented in Fig. 4. This information will be pivotal in the subsequent slope stability analysis.

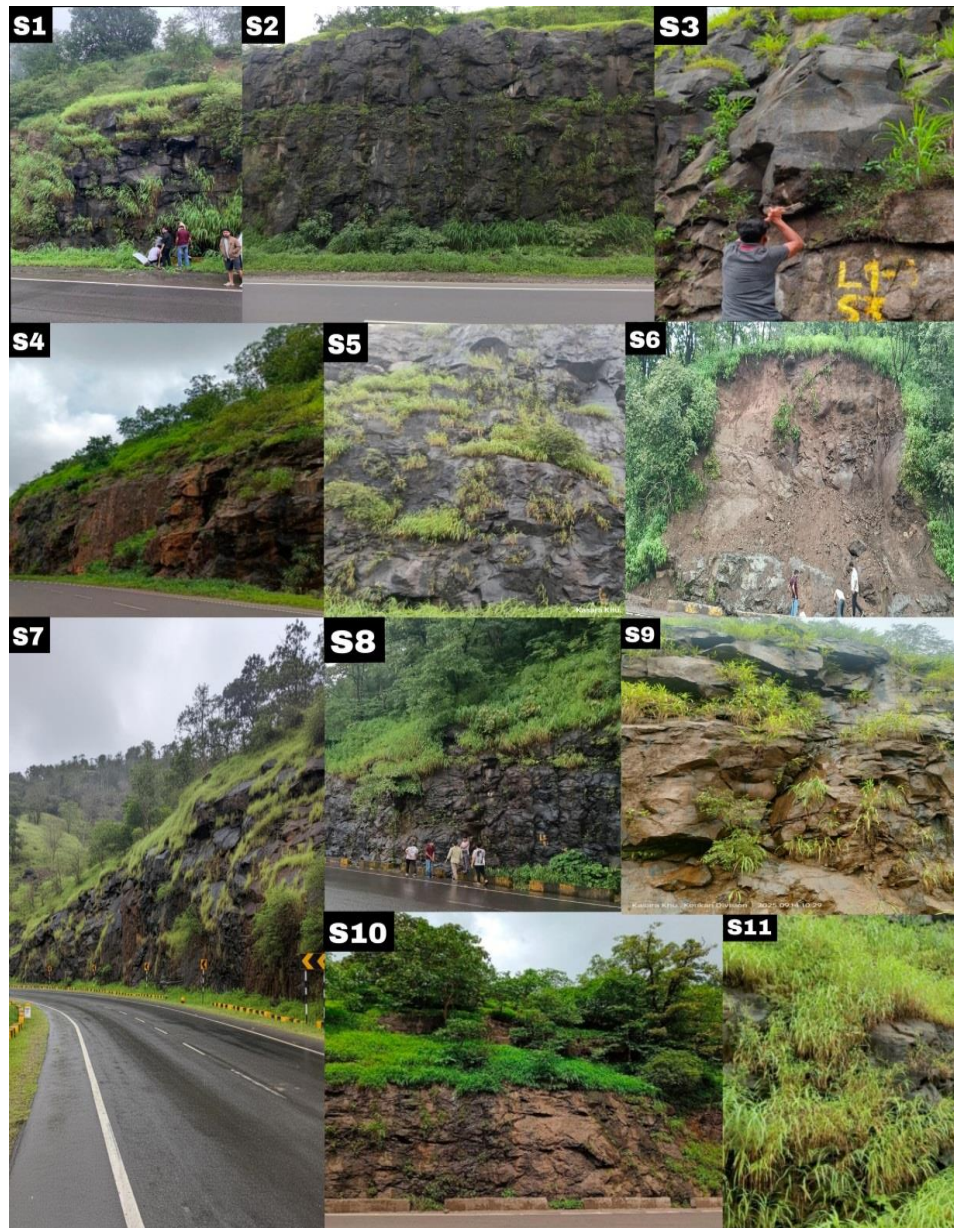
**Figure 4.** Field photographs depicting the condition of investigated slopes along NH3 (S1, S2, etc. Names of Slopes for field identification).

Soil and rock samples were collected from each of the 11 locations using hand augers and by manual extraction of representative rock fragments from exposed cut faces at depths of approximately 0.5-1.5 m below the existing slope surface. At locations where multiple sub-samples were collected (e.g., L1S2, L3S1), each sub-sample was tested independently, and the resulting range of values (Table 2) illustrates the local variability in material properties attributable to heterogeneous weathering as observed in Fig. 4.

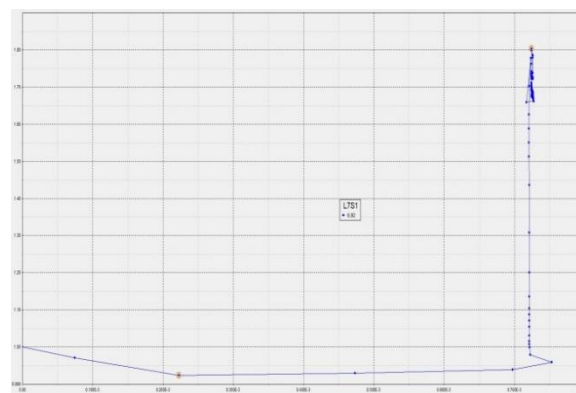
Deformed Soil Model (Output) (L7)

FoS Curve for Soil Model (L7)

**Figure 14.** Representation of numerical analysis output for the cut slope L7.**Table 11.** Summary of FoS as per the numerical method.

| Sr. No | Location | Slope | FoS | Status |
|---|---|---|---|---|
| 7 | L7 | - | 0.92 | Severely fractured |

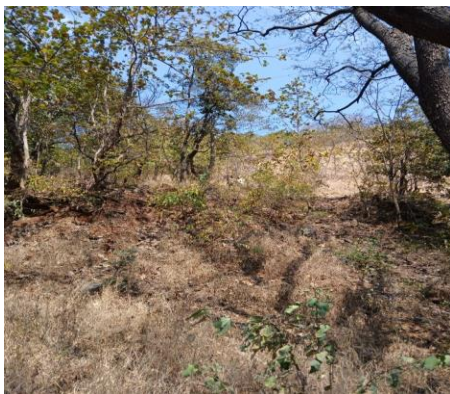
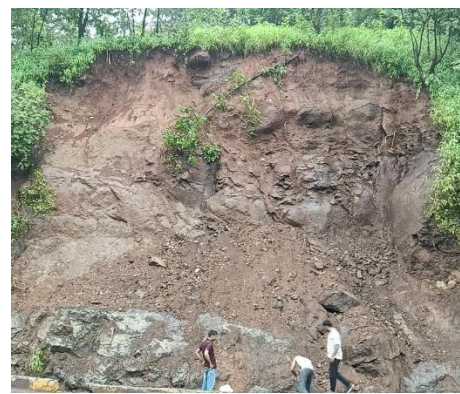
Photographs of the slope at Location 6 taken before failure in February 2025 and after failure in September 2025 are presented in Fig. 16, providing direct ground validation of the stability analysis.

Date: 02/02/2025

Date: 14/09/2025

**Figure 16.** Photos of the slope at Location 6 before and after failure in the same year during the summer and rainy seasons.

Table 14 shows that in addition to Location 6 (FoS = 0.86-0.88 failed), slope L1S1 also returned an FoS below unity (0.65-0.86) and is recorded as Failed (where L1S1 and L6 both failed during the September 2025 rainfall). The remaining slopes at L1 (S2, S3) and L2 (S1, S2, S3) have FoS values ranging from 0.90 to 1.13, close to but not below unity in several locations, and are classified as Severely Fractured or 'Nearly Failed' rather than 'Failed'. A FoS marginally below or near 1.0 indicates a state of marginal stability under the assumed monsoon/saturated condition. Whether or not failure actually occurs depends on whether a sufficient triggering event occurs at that specific location and time.

Combined graphical and numerical analyses indicate that slopes L1S1 and Location 6 (L6) have FoS values below unity (0.65–0.86 and 0.86–0.88, respectively) and both failed during the September 2025 monsoon. This provides direct ground validation of the analysis. Slopes L1S2, L1S3, L2S1, L2S2, L2S3, L5 and L7 have FoS values ranging from approximately 0.90 to 1.13, placing them in a state of marginal stability that warrants immediate remedial attention. Particularly given the sensitivity of pore water pressure (and hence FoS) to high-intensity rainfall events such as the 944 mm/day event recorded historically in this region.
