MONITORING OF HIGH RISE BUILDING USING VERY LONG FOCAL LENGTH OF CAMERA LENS AND THREE DIMENSIONS GOOGLE IMAGES

Dr.Entisar Kadhim Al-Geelawe¹, Dr.Layth Sadek Mohsin²

- 1) Assistant Prof., Civil Engineering Department, University of Baghdad, Baghdad, Iraq.
- 2) Lecturer Civil Engineering Department, Mustansiriyah University, Baghdad, Iraq.

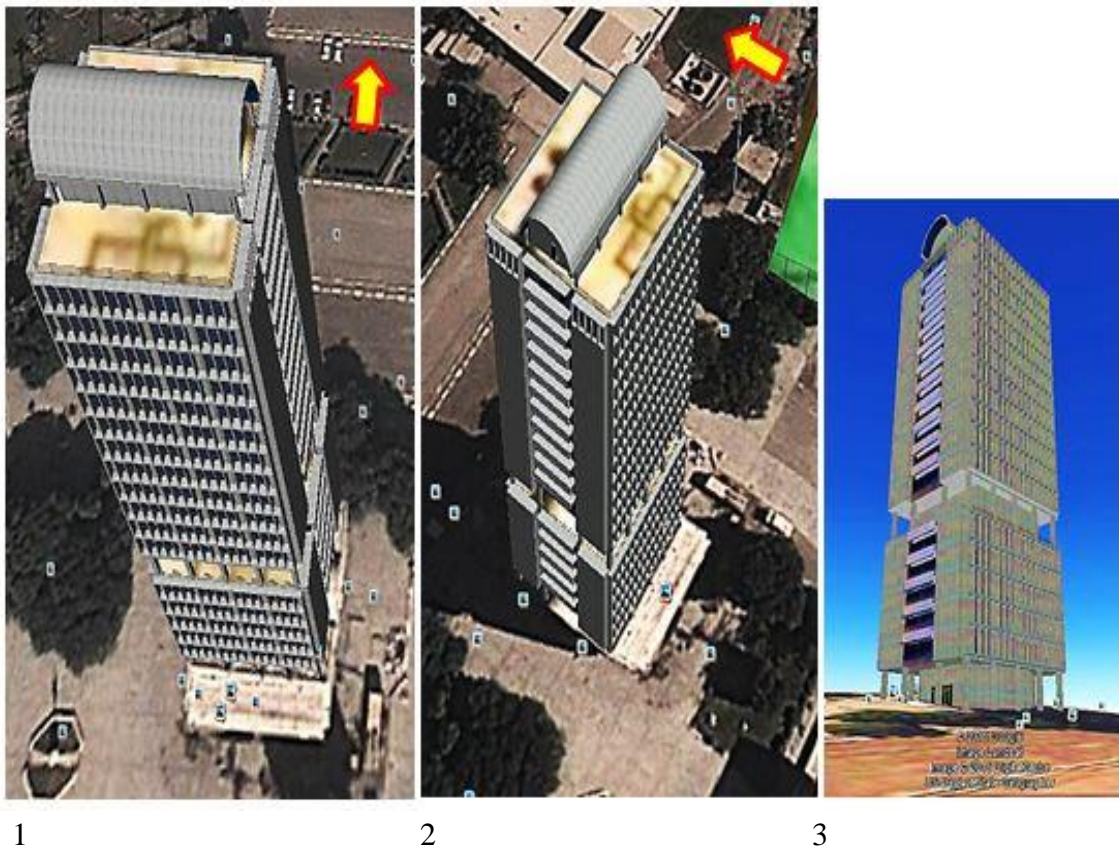
Fig. 11 Google different views of the tower of University of Baghdad (the perspective can be viewed, shifted and rotated at any angle even from ground level as in 1, 2, &3).

The perspective view of a construction in Google 3D map offer many advantages as shown in Fig. 11 which are:

1. It can offer more details in upper parts than any other images. Such images cannot be taken by normal ways.
2. The perspective view can be rotated and shifted to any direction to show its front, side and any other views.
3. The ability to show any details at any angle of view simply, clearly and without missing any other details.
4. The use of 3D Google images also presents the geographic position and direction of the building with respect to the North or any direction by presenting the accurate horizontal angle with respect to its direction.
