THE APPLICATION OF ACCURATE DIGITAL CAMERAS WITH GPS AND USE THE GOOGLE IMAGES FOR MONITORING HIGHWAY BRIDGES

Dr.Entisar Kadhim Al-Geelawe¹, Dr.Layth Sadek Mohsin²

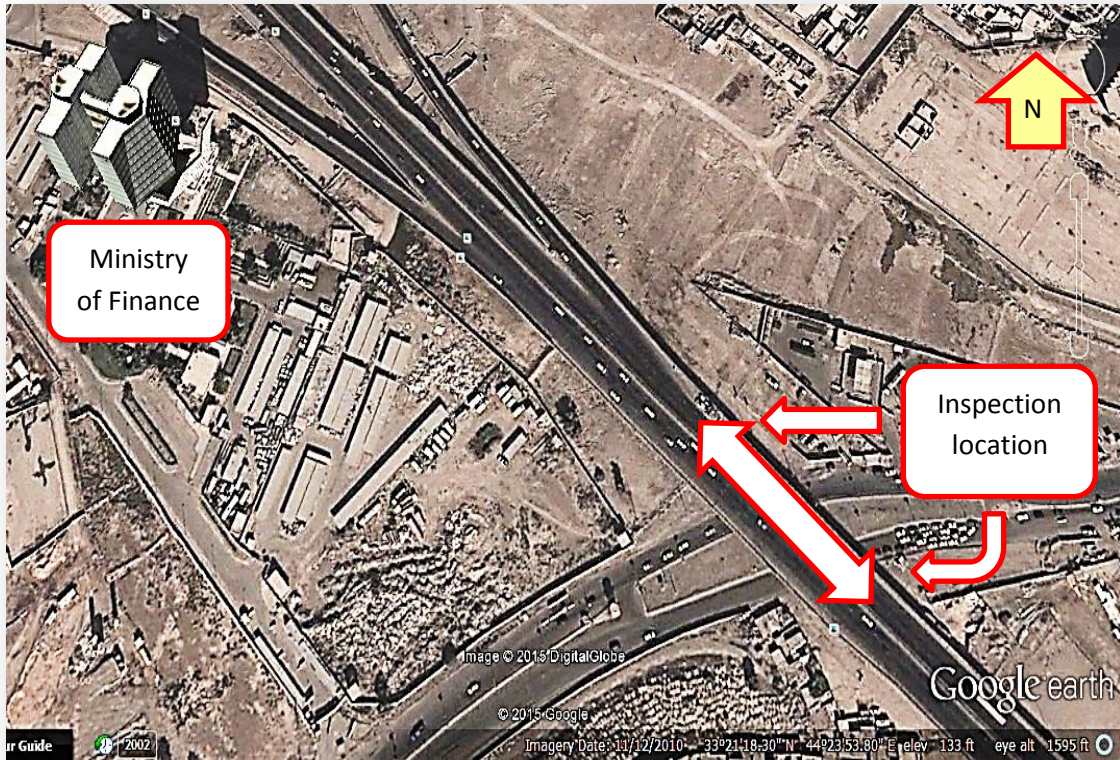
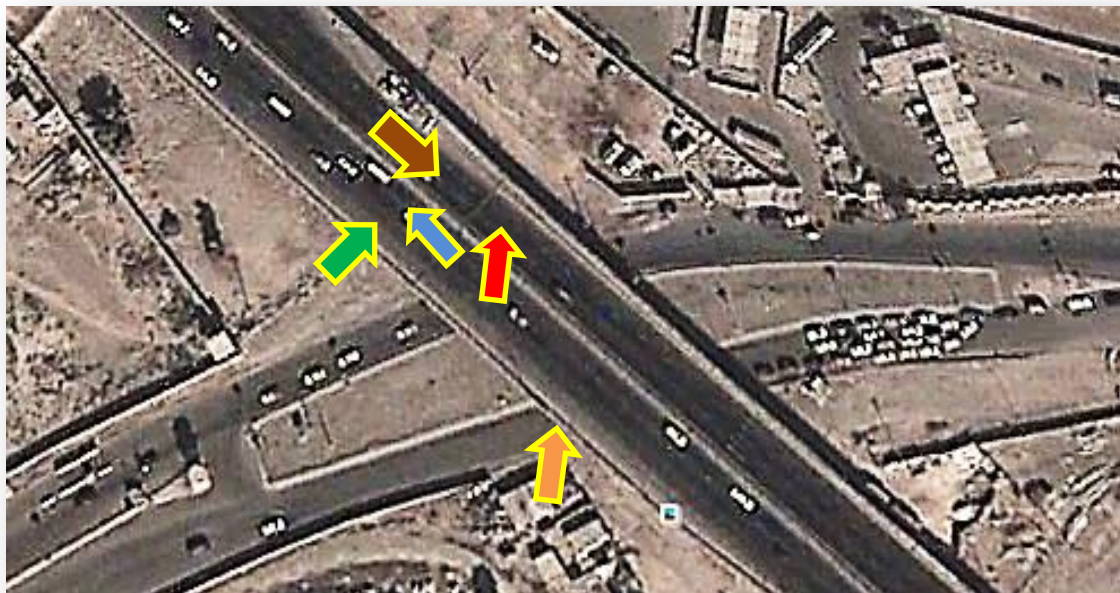
The first location was in the Mohammed Al-Qassim bridge over Sheikh Omar Street as shown in fig. 4. The colored arrows identify the locations and directions of the images of damages.

Fig. 4 Google Images of the Mohammed Al-Qassim Bridge location across Sheikh Omar Street with GPS Coordinates (axis) in the upper image, while the lower image shows the colored arrows that identify location and direction of the images of the damages which are shown below.

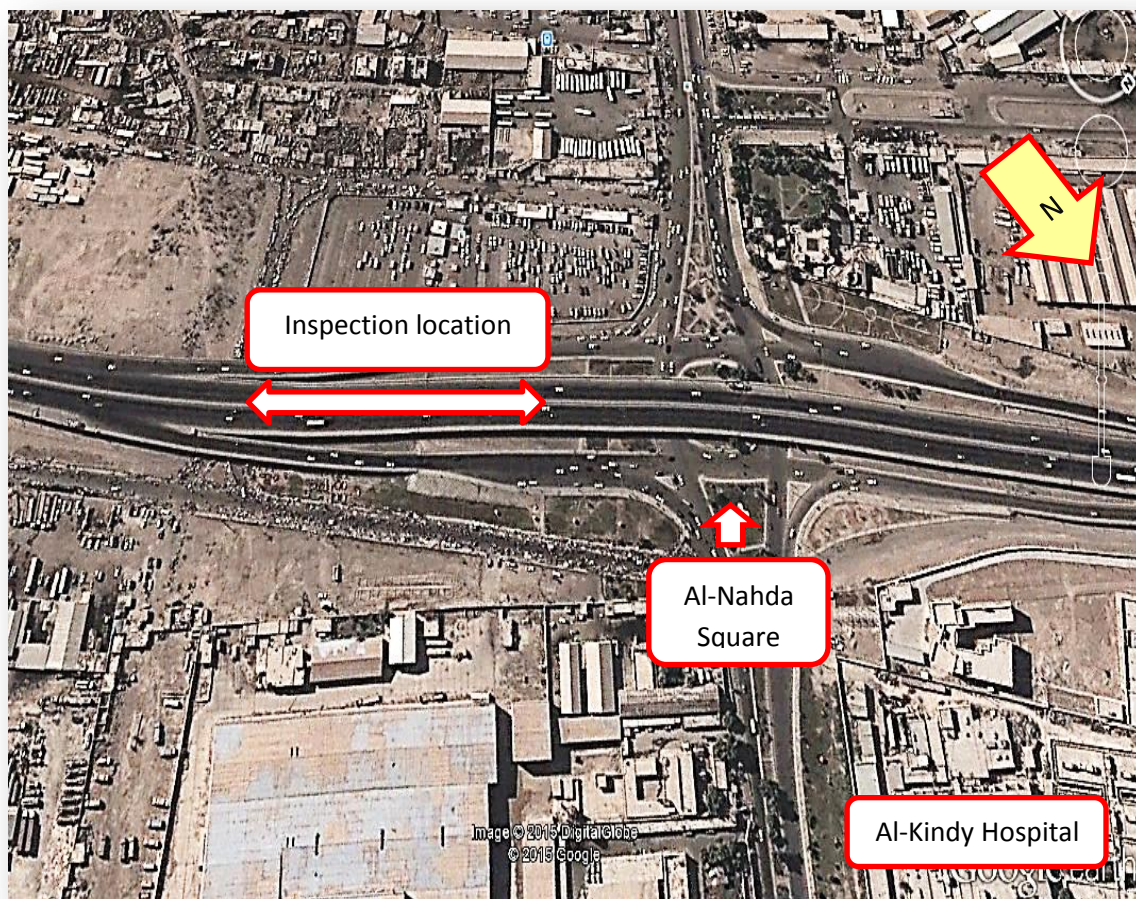
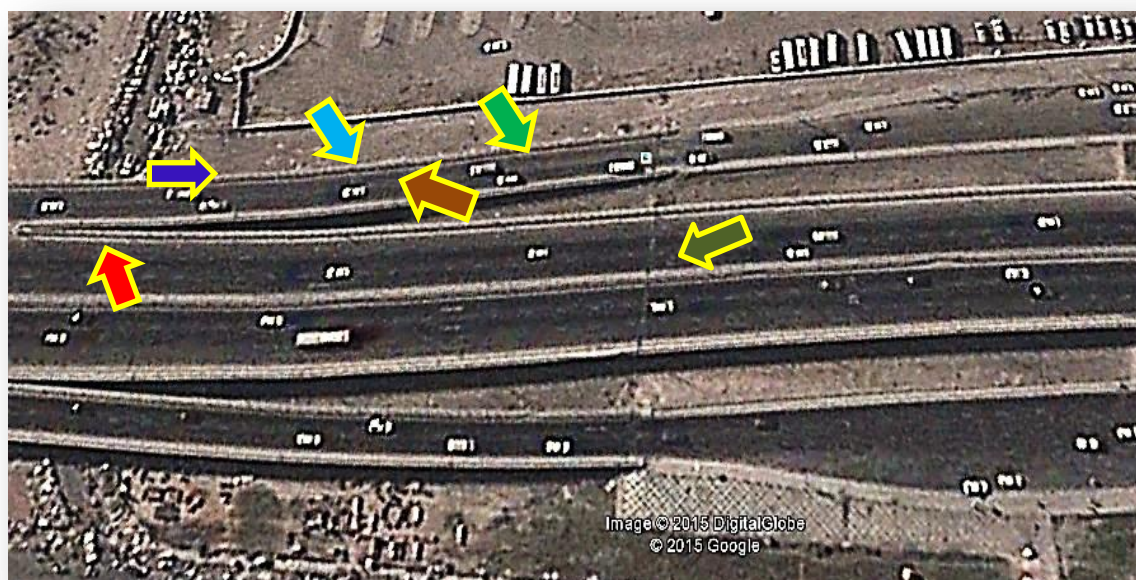
The second location was in Mohammad Al-Qassim highway across Al-Nahda square (see fig. 10) and as it is shown before, the colored arrows identify the location and direction of the images.

Fig. 10 Google Images of the Mohammed Al-Qassim Bridge across Al-Nahda Square (Colored arrows identify images location and direction).
